# Managing Threats to the Tankerhoosen River Watershed: A Plan for Protecting Its Water Quality and Ecological Health

February 26, 2009

# Purpose of Tonight's Meeting

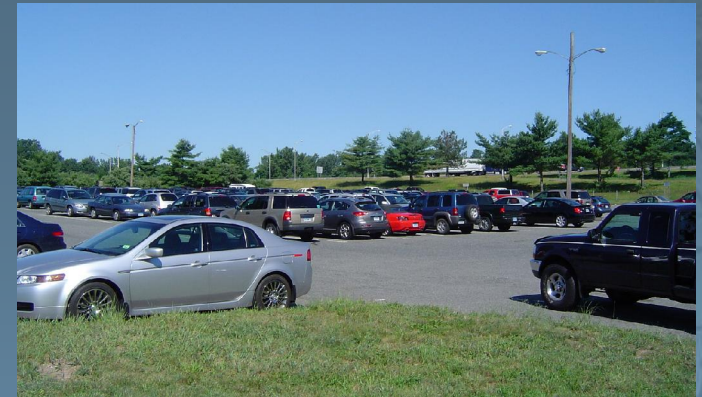
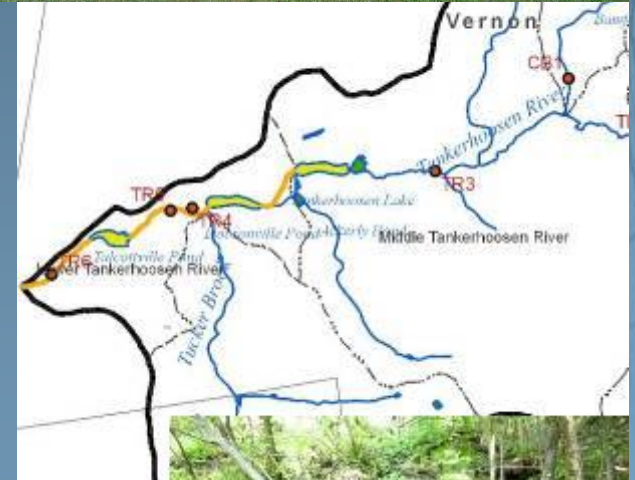
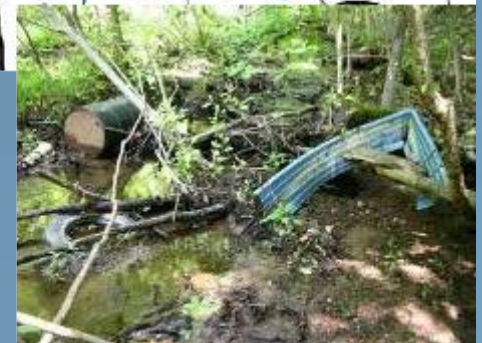
# Potential Threats

- Development pressure in headwaters region
  - *I-84 Exit 67*
  - *Tolland Industrial Park*
  - *Interstate 84*
- Water quality impacted in lower reaches
  - *Cited as impaired by DEP*
  - *Nonpoint source runoff, stormwater*

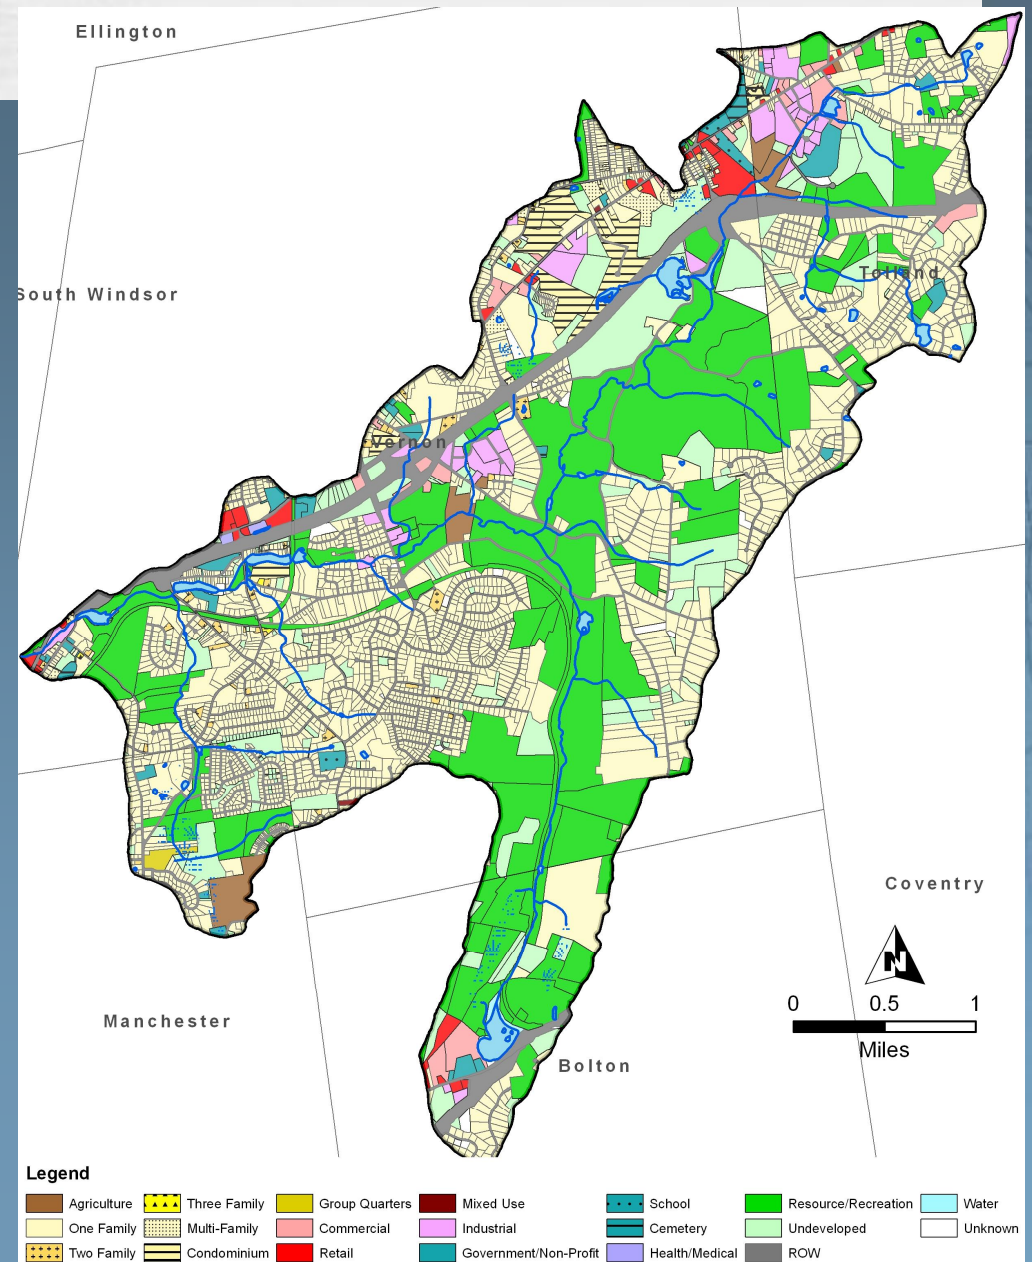
# Land Use

- CRCOG Land Use (2003)
- 60% developed land use (40% residential)
- 4% commercial and industrial
- 9% roads and highway
- 30% committed and uncommitted open space

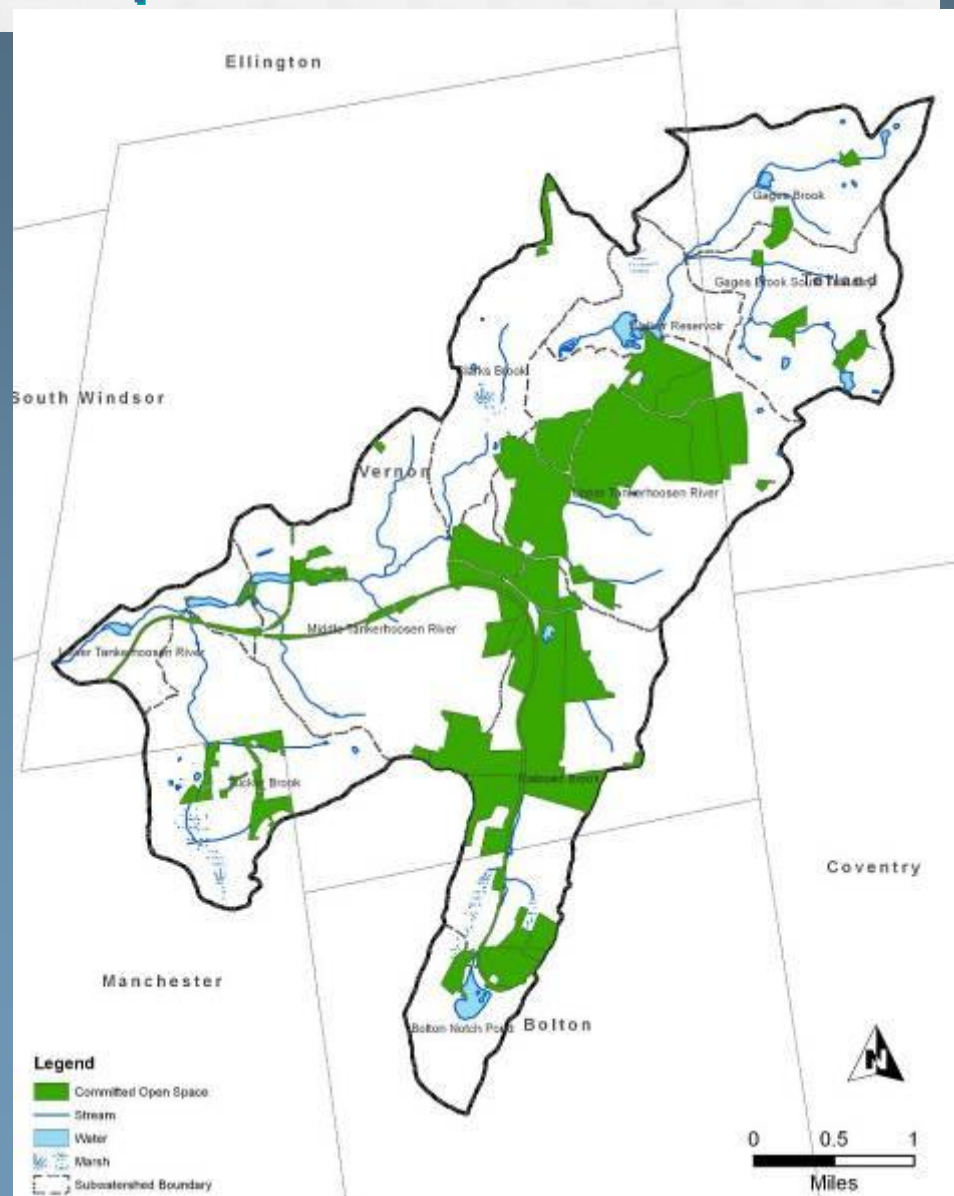
# Protected Open Space

- CRCOG Land Use
- Confirmation by Vernon and Bolton representatives
- Manchester and Tolland POCD
- Deeded open space privately owned
- Land trusts
- State land
- Town park land

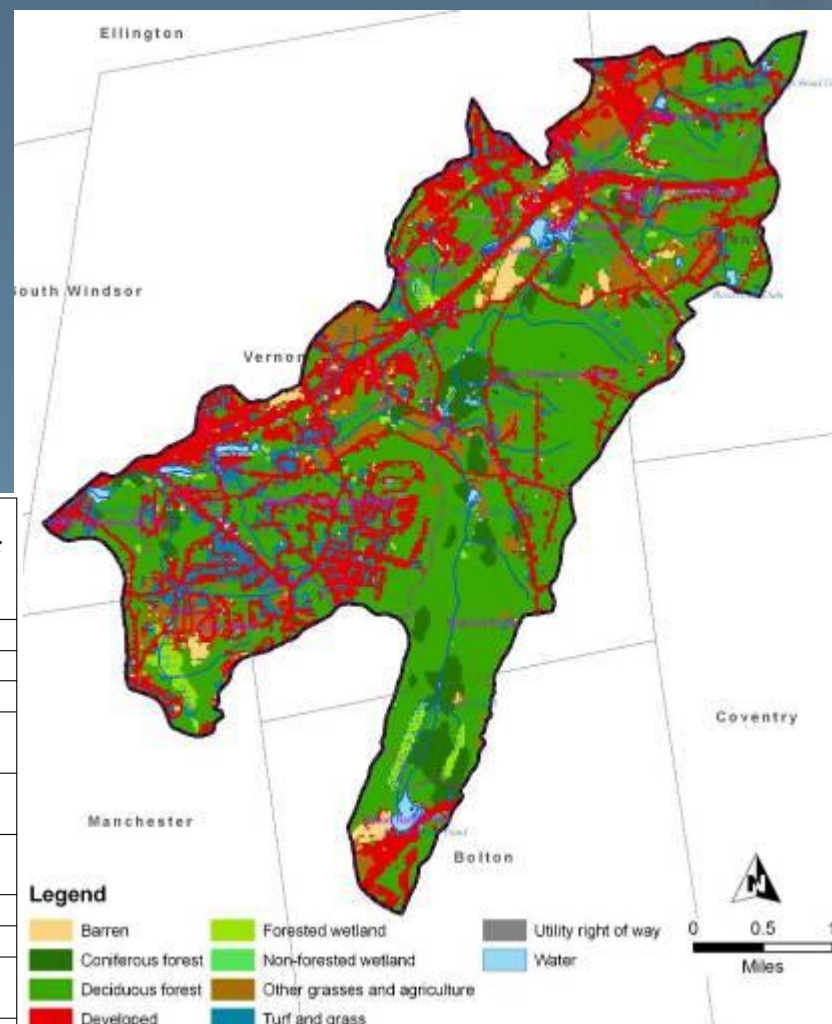
# Forest Cover

- 55% of watershed is forested
- Subwatersheds: 31% to 86%
- 65% literature threshold for healthy aquatic invertebrate community
- 40% threshold goal for urban areas
- Significant “developable” forest cover

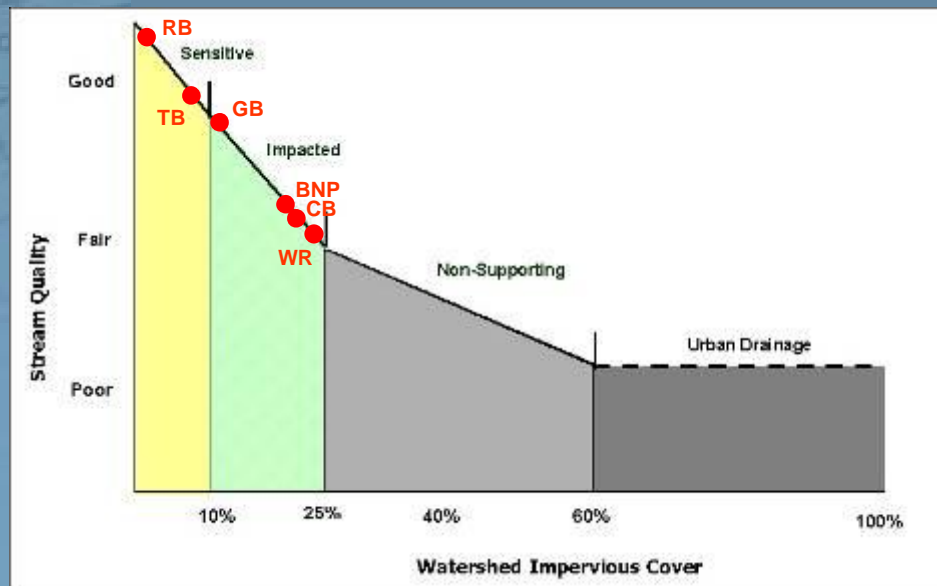
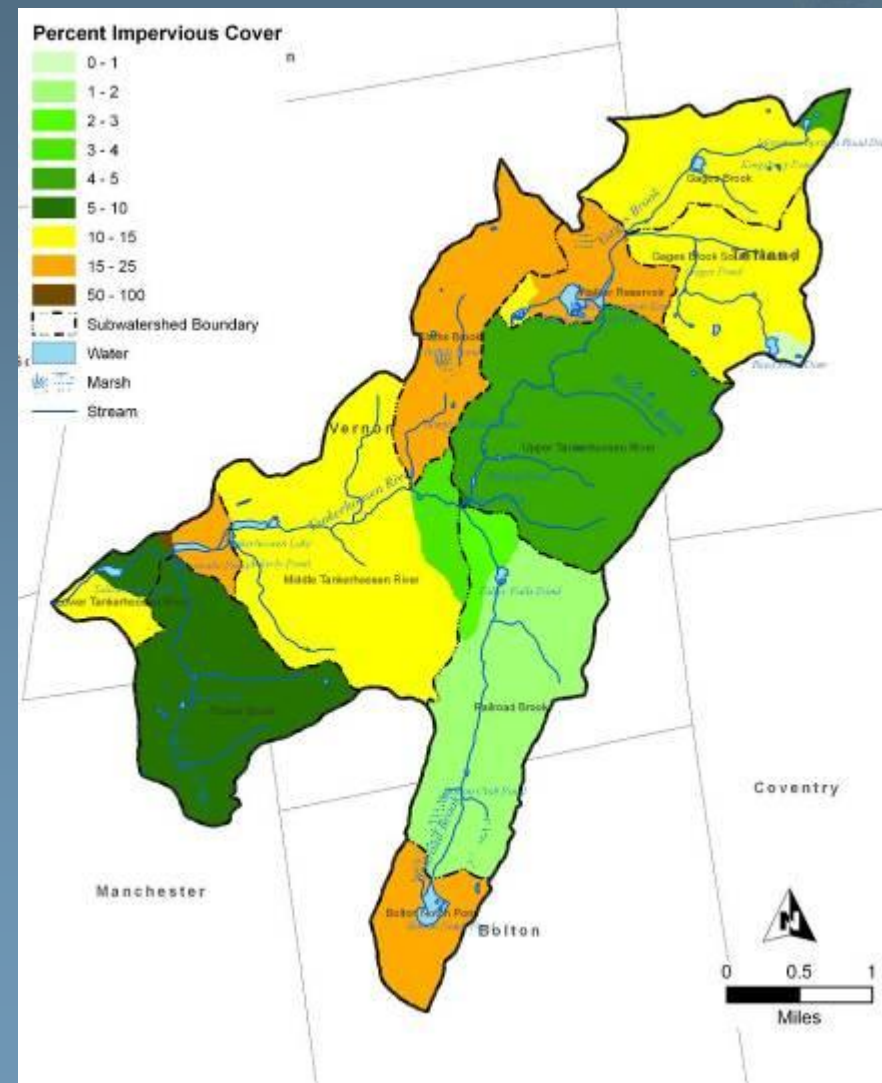
# Impervious Cover

- 2002 satellite imagery
- Overall watershed IC is 9.7%
- Gages Brook IC at 11.5%
- Impervious Cover Model
- Statewide impairment threshold of 12%

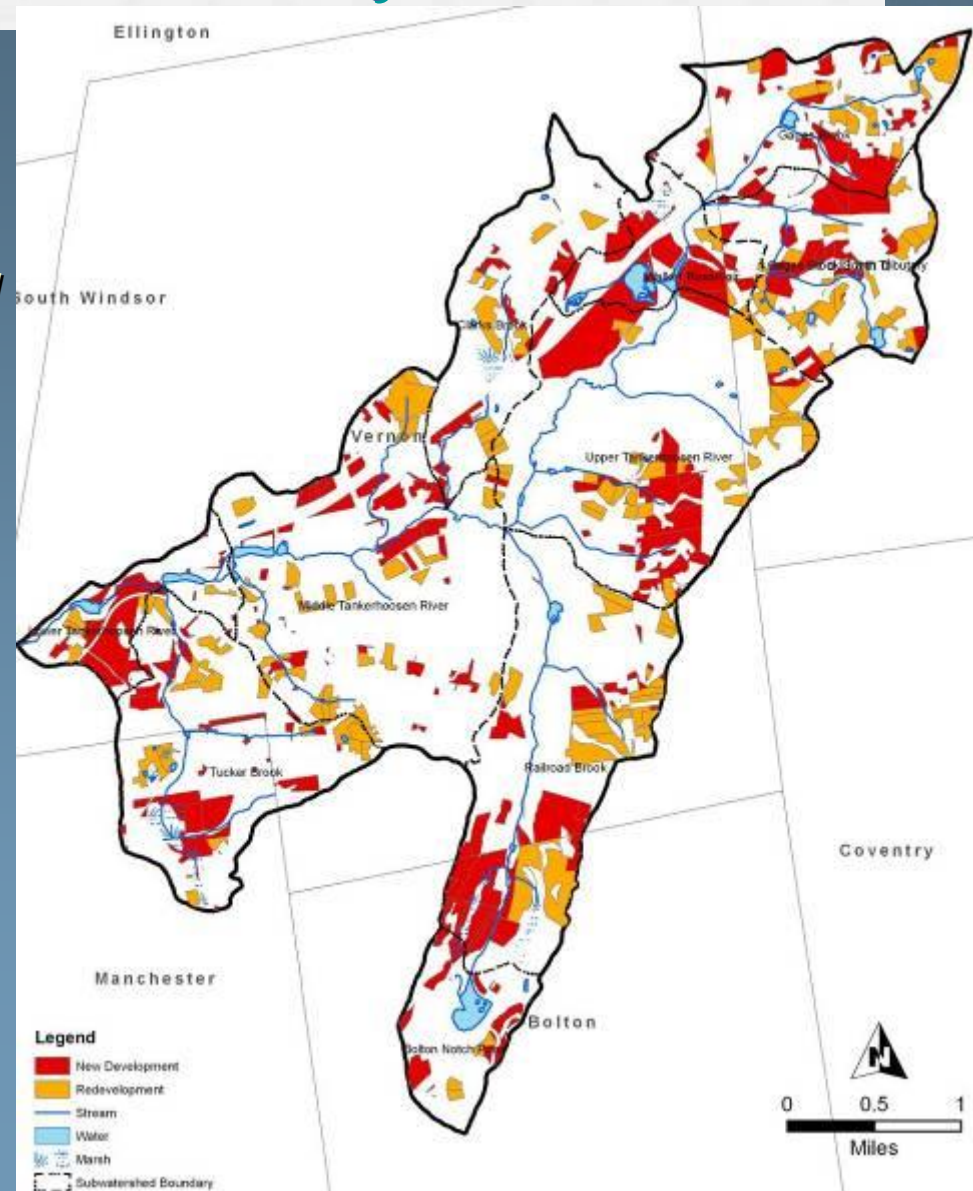
# Watershed Buildout Analysis

- Potential full buildout of watershed
- Developable land
  - *New development (undeveloped and uncommitted open space)*
  - *Redevelopment (large lot residential that could be further subdivided)*
  - *Water bodies, wetlands, and steep slope soils excluded*
- Assign future land use of developable land based on zoning
- 15% increase in residential
- 3% increase in commercial/industrial
- 14% decrease in undeveloped and uncommitted open space

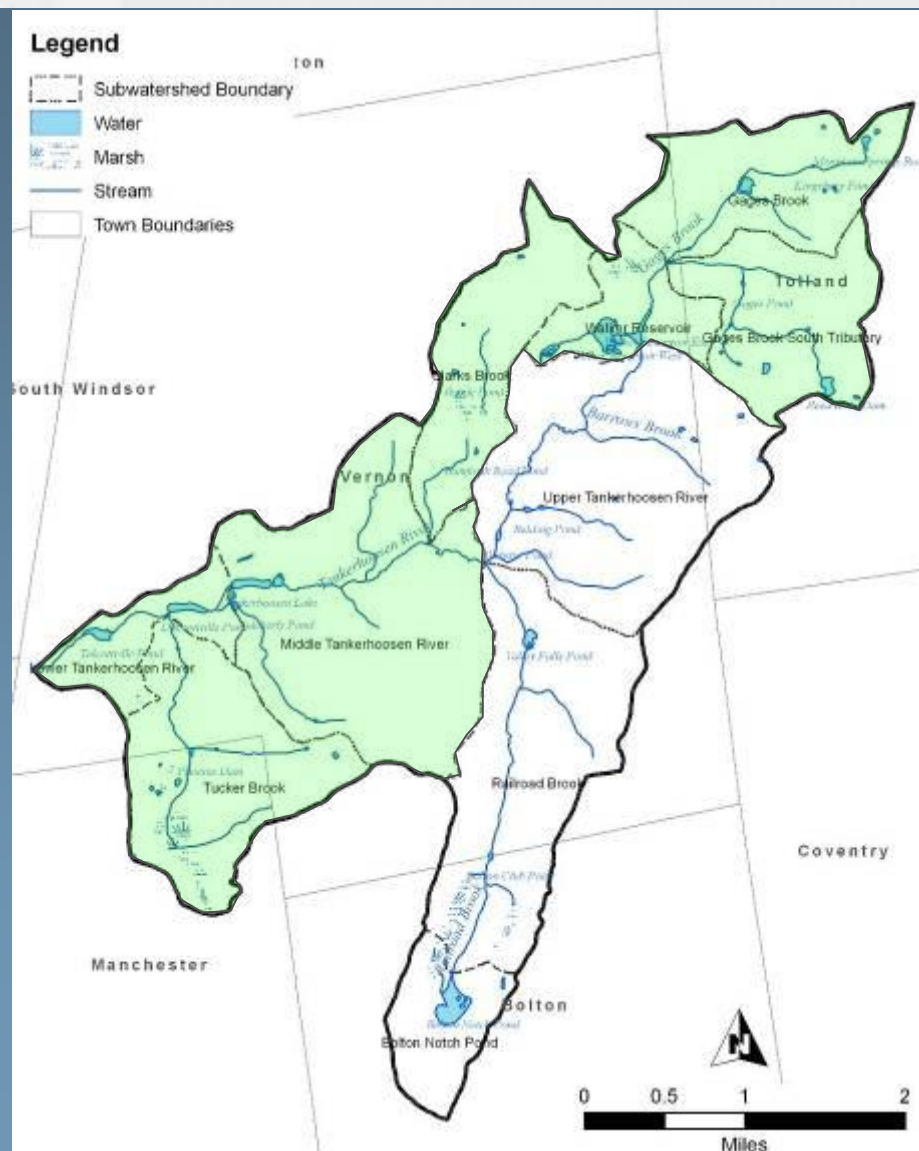
# Priority Subwatersheds

- Field inventories performed in priority subwatersheds
- 8.7 miles of streams assessed
- June 3-6, July 2, and July 10 stream surveys
- Efforts targeted at stream segments and upland areas with greatest potential stream impacts

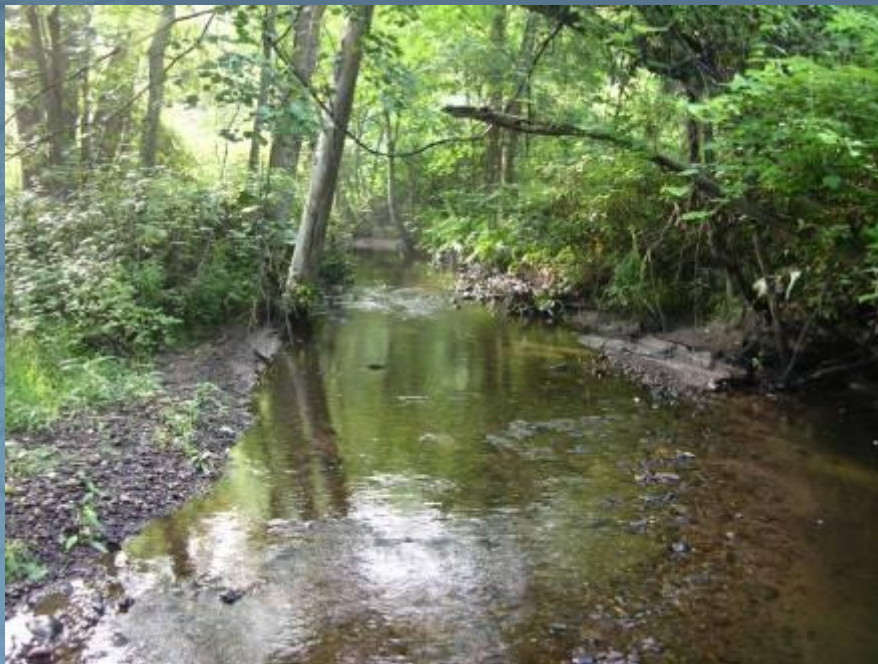
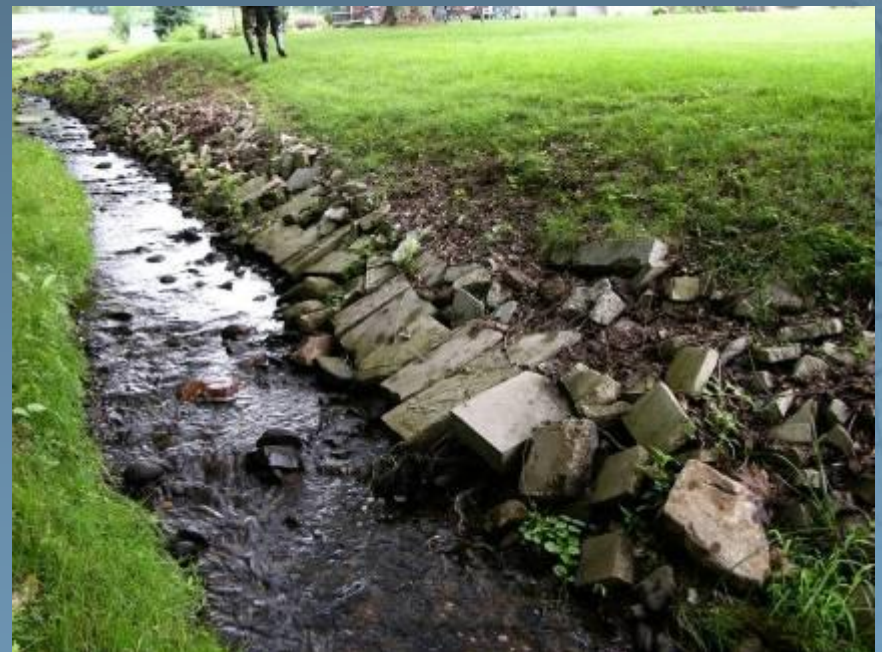
# In-Stream Habitat

- In-stream habitat mixed, even in same subwatershed

- Majority of reaches appear to support biological communities (fish, frogs, birds)

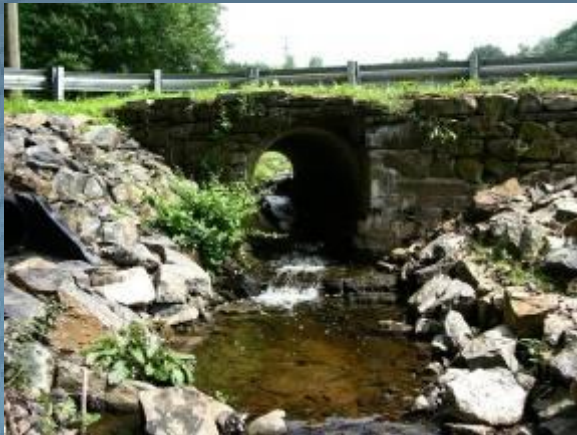
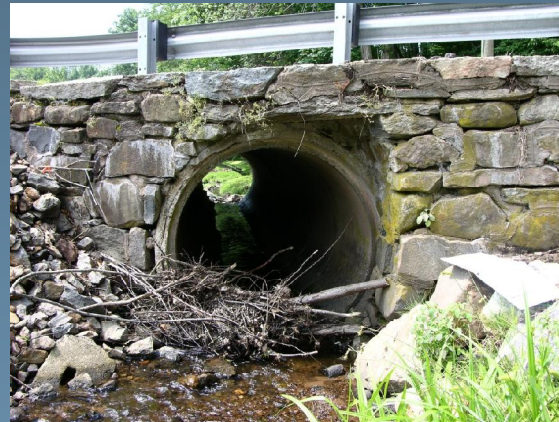
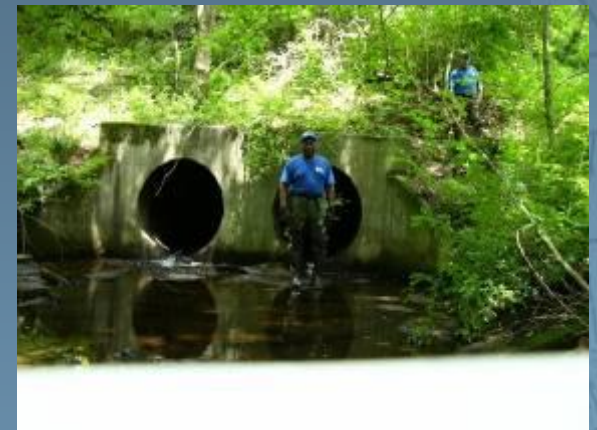
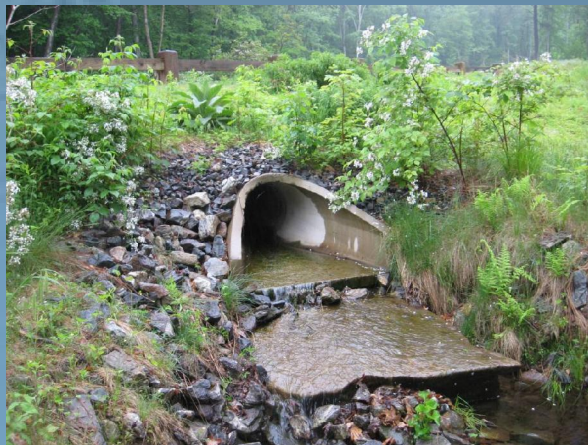
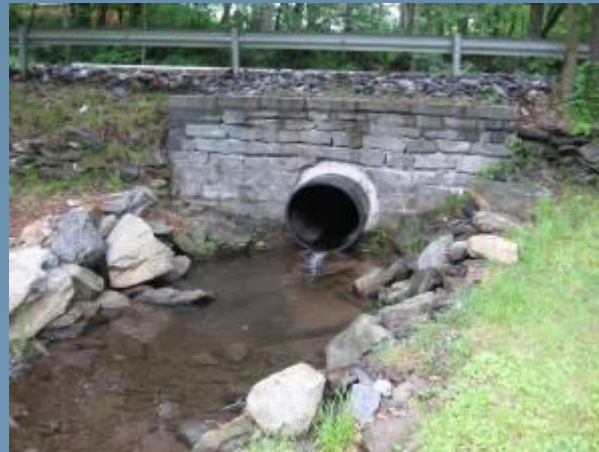
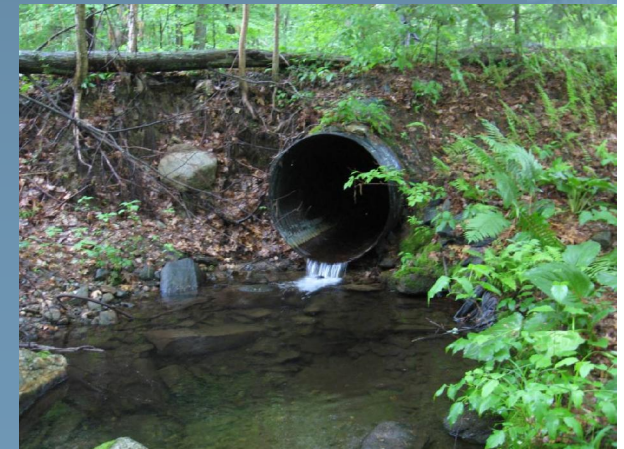
# Fish Passage

- Many potential barriers to fish passage
  - *Perched culverts, culverts with shallow flow, dams*

- Many existing and potential barriers to fish passage
- Field inventory along Upper Tankerhoosen
  - *Proposed removal of Belding Pond Dam could provide for additional passage to Walker Reservoir*
- Evaluate Lower Tankerhoosen
  - *Presence of American eel and other resident fish populations*
  - *Include fish passage provisions with future dam repairs*

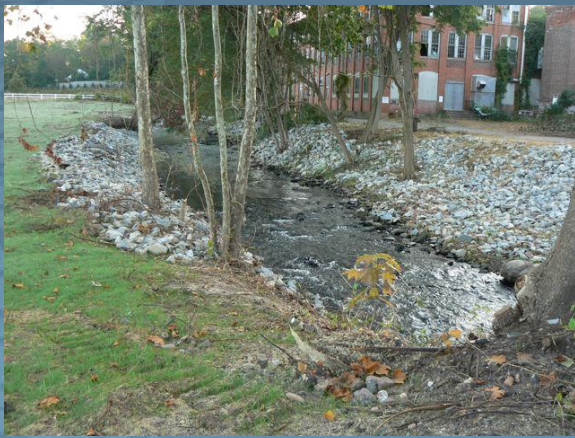
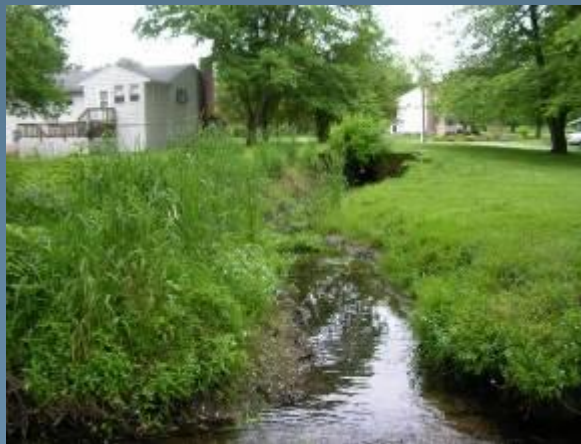
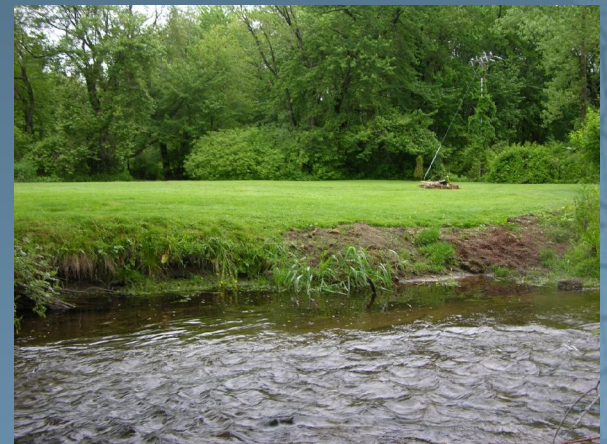
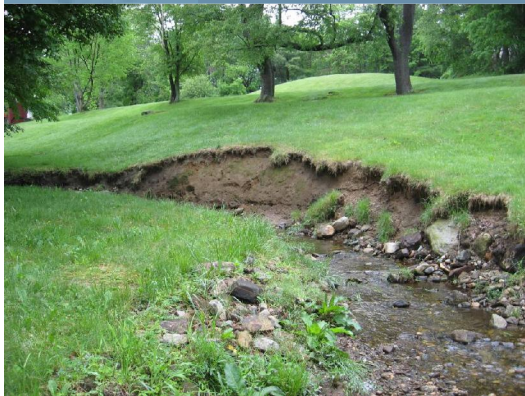
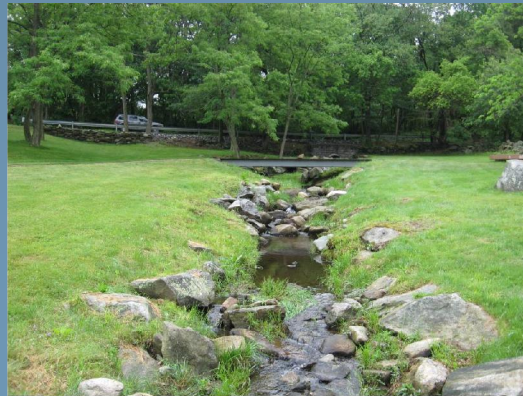
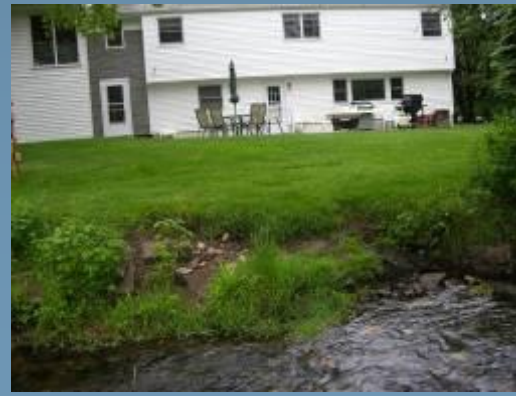
# Stream Buffer Encroachments

- Stream buffer encroachments common
  - *Residential, commercial areas*

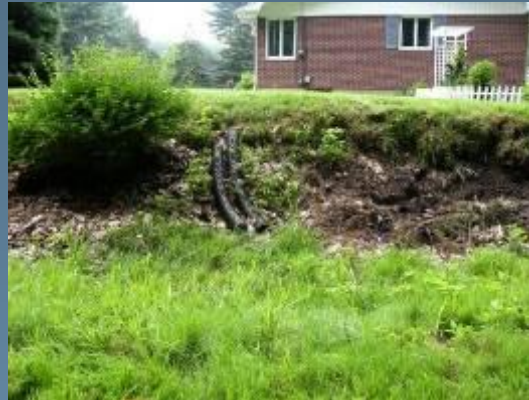
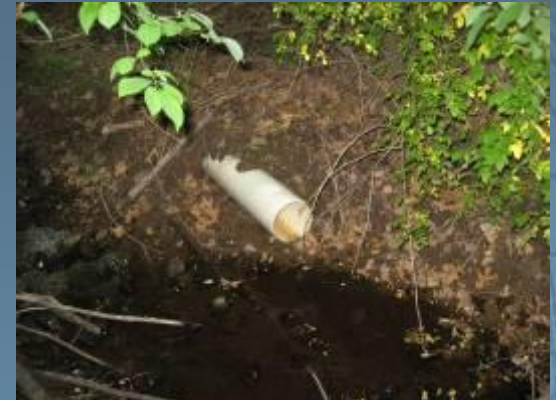
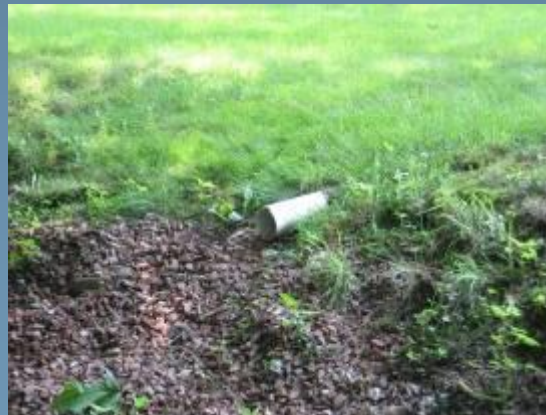
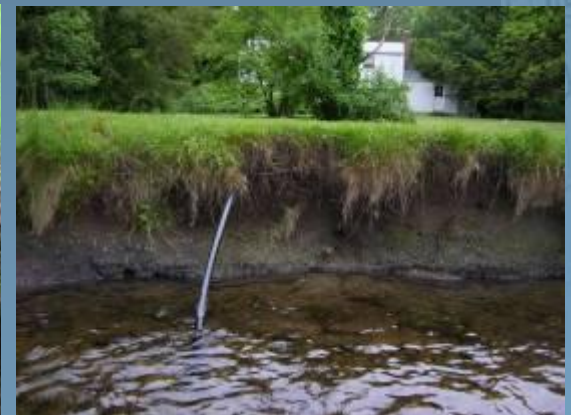
# Residential Runoff

- Residential areas contribute significant runoff
  - *Medium and high density neighborhoods with small yards*
  - *Many outfall pipes to stream (foundation drains, yard drains, downspouts)*
  - *Little or no stream buffer*

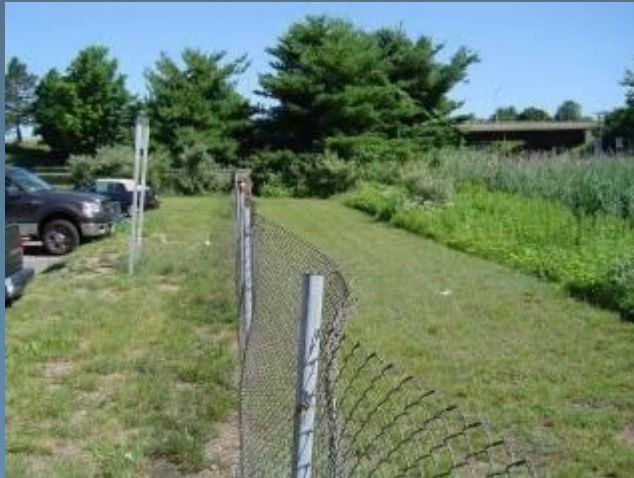
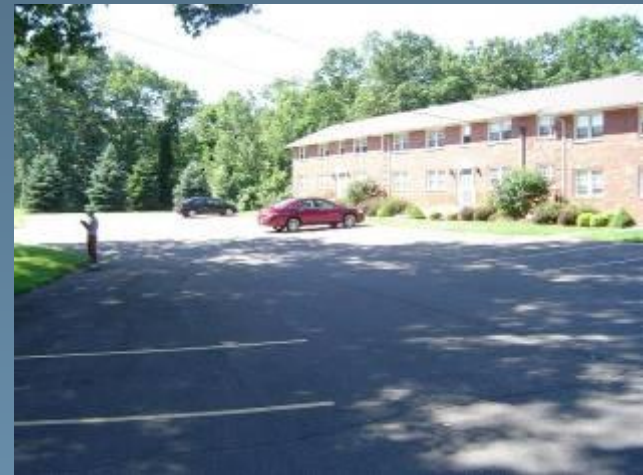
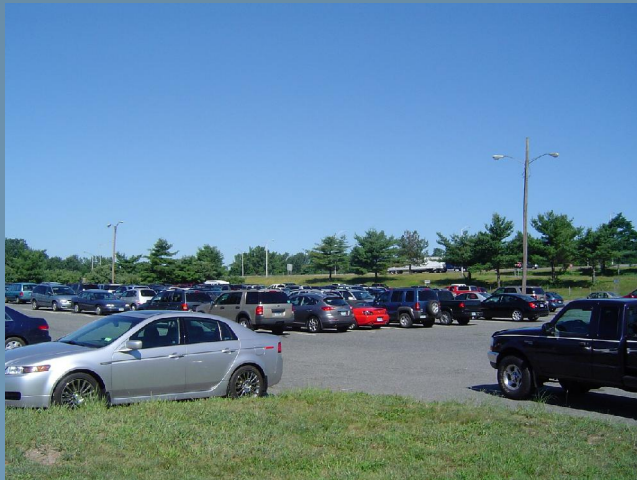
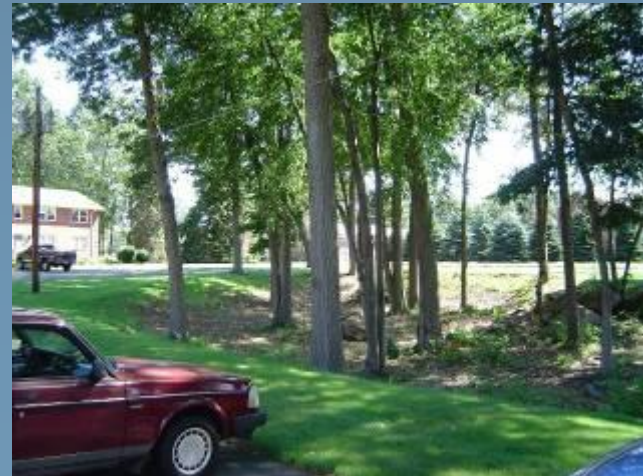
# Parking Lots

- Potential candidates for stormwater retrofits

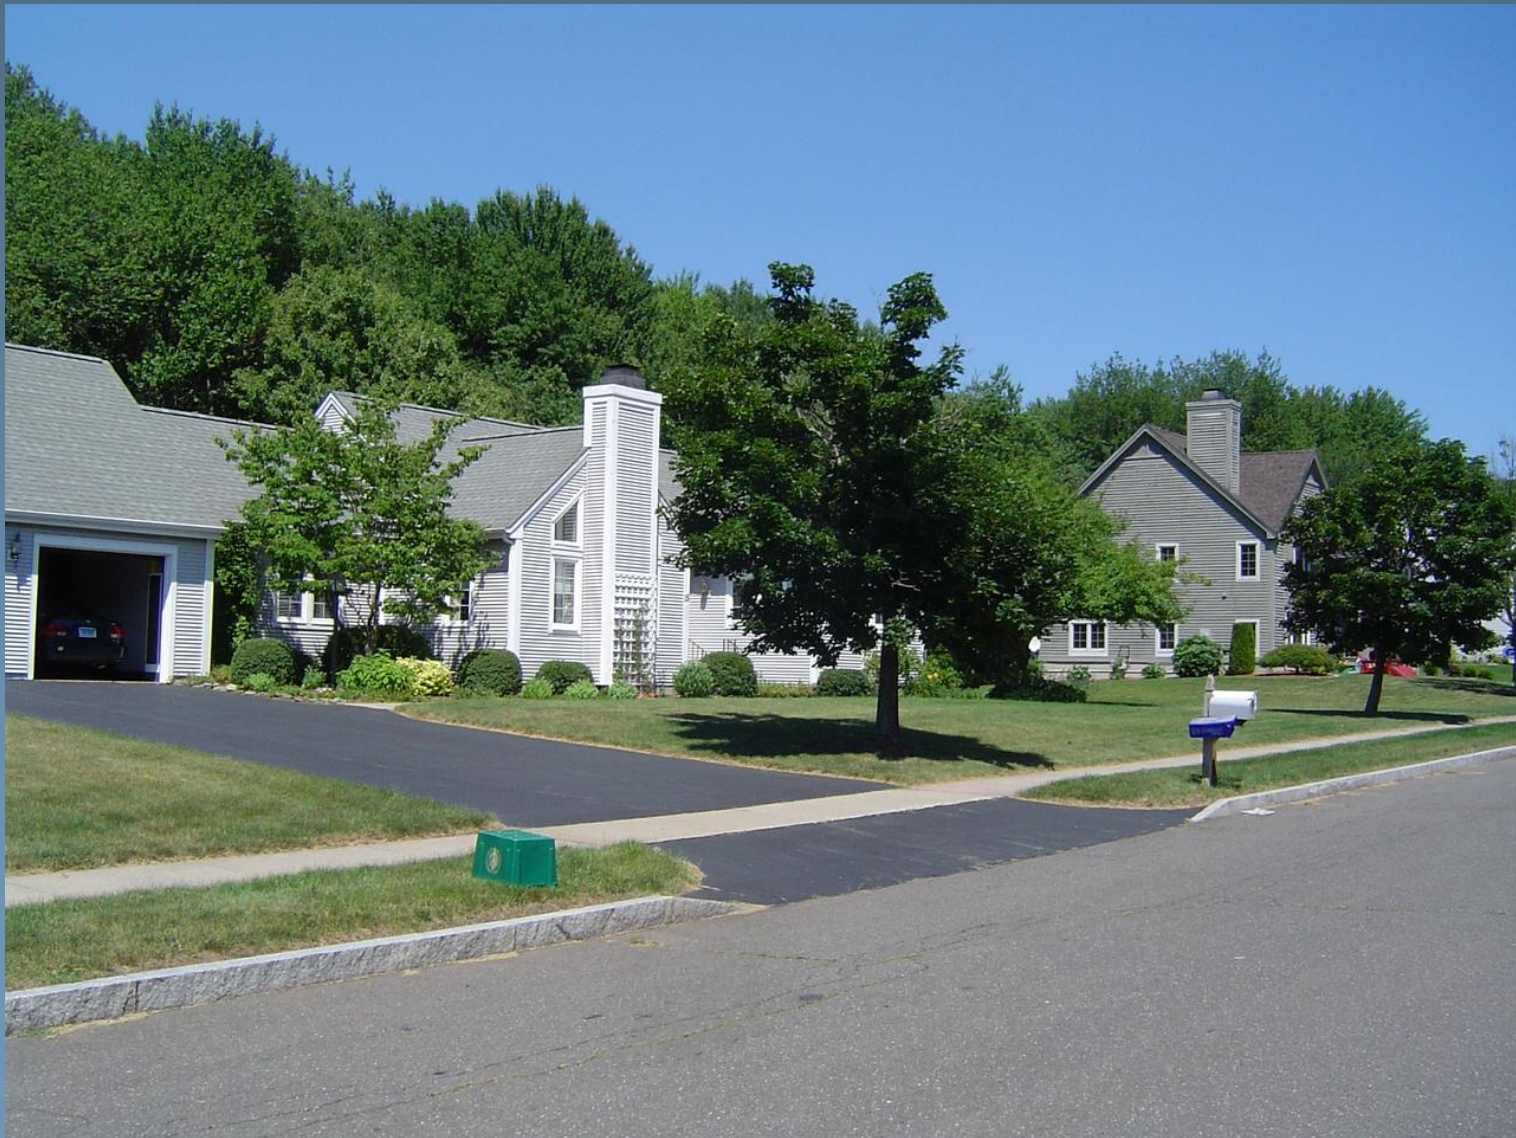
# Traditional Curb and Gutter Drainage

- Many residential developments pre-date modern stormwater controls
- Traditional curb and gutter and closed drainage systems
- No LID design practices observed
- Existing stormwater management systems not being maintained
- Untreated runoff from roads and highways

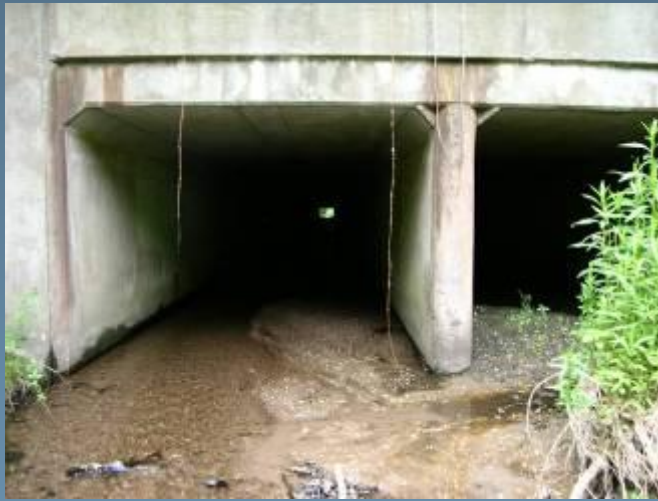
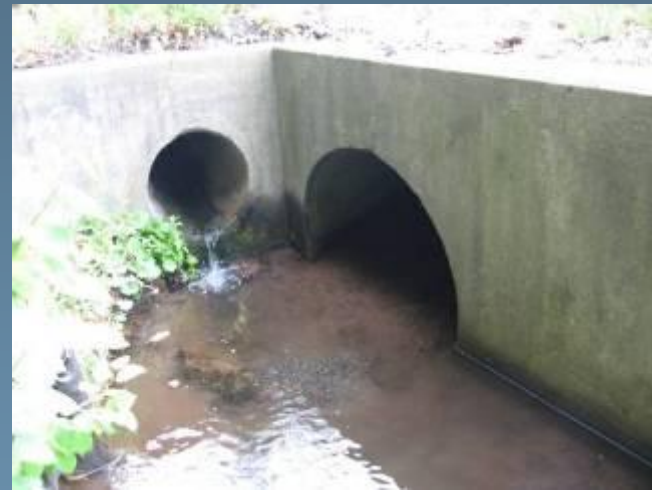
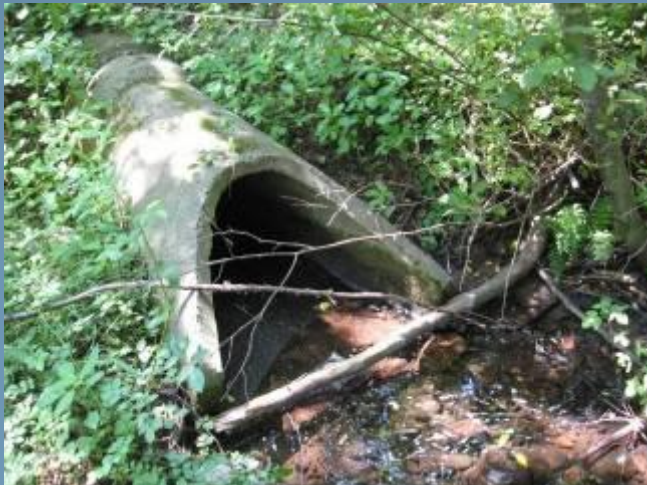
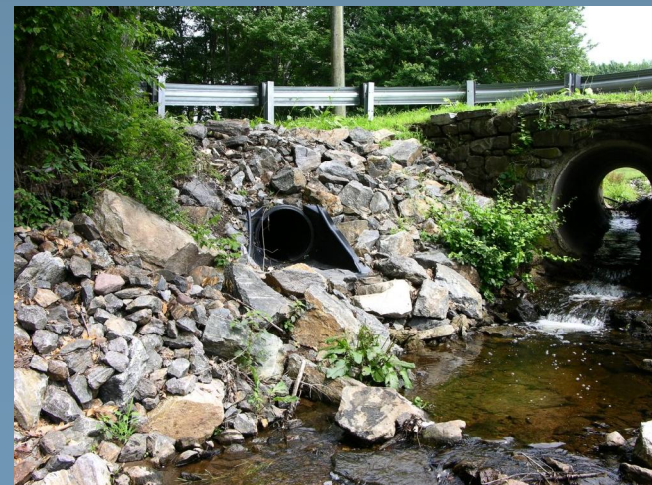
# Untreated Roadway Runoff

- Source of sediment and other pollutants

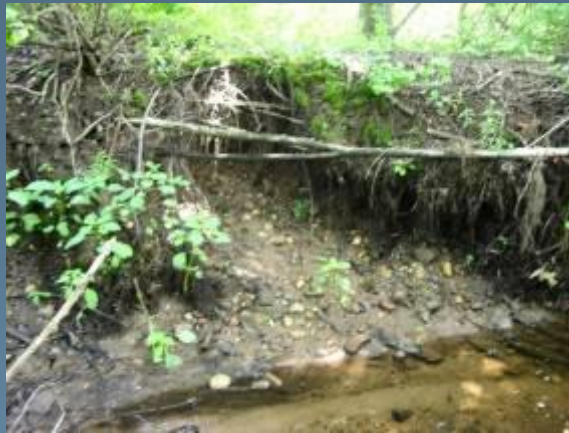
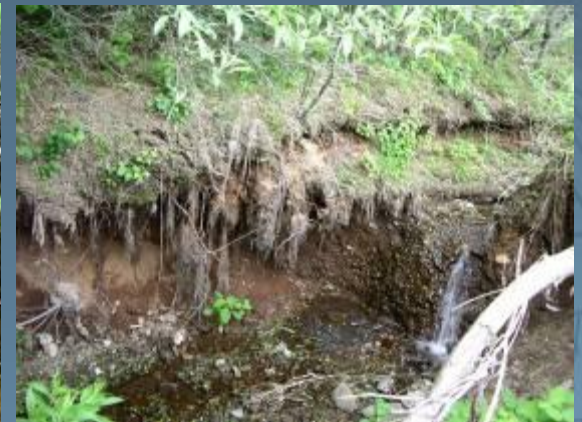
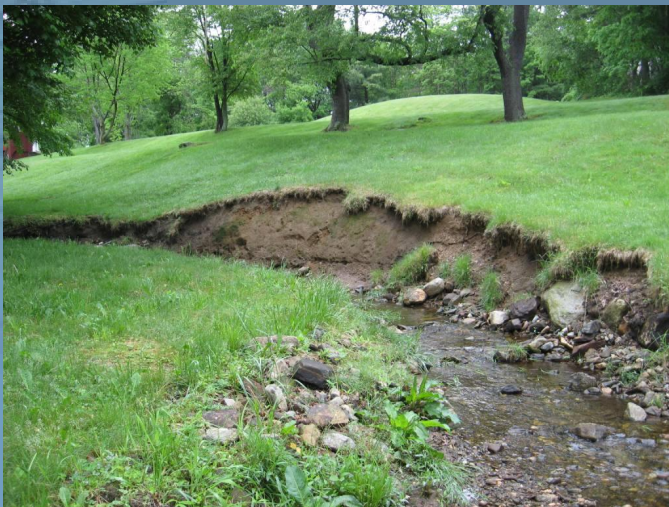
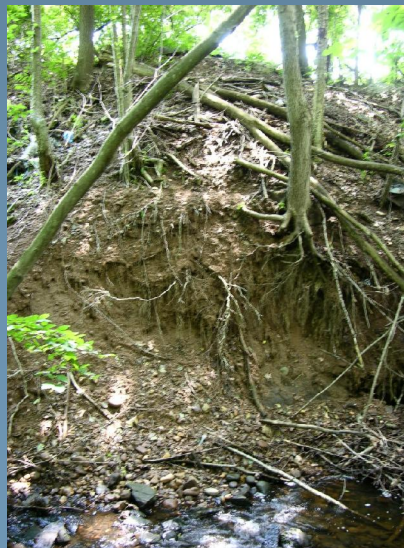
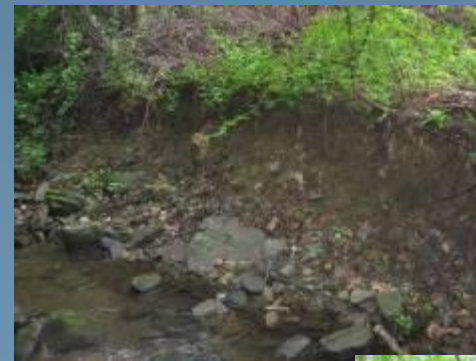
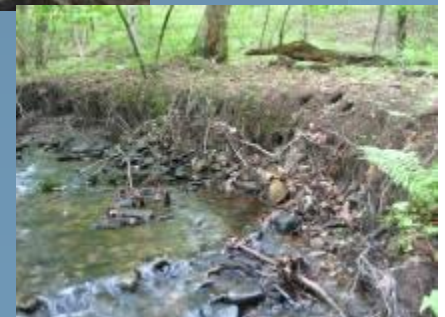
# Streambank Erosion

- Relatively isolated areas of moderate to severe bank erosion
- Most located at or downstream of stormwater outfalls
- Limited access

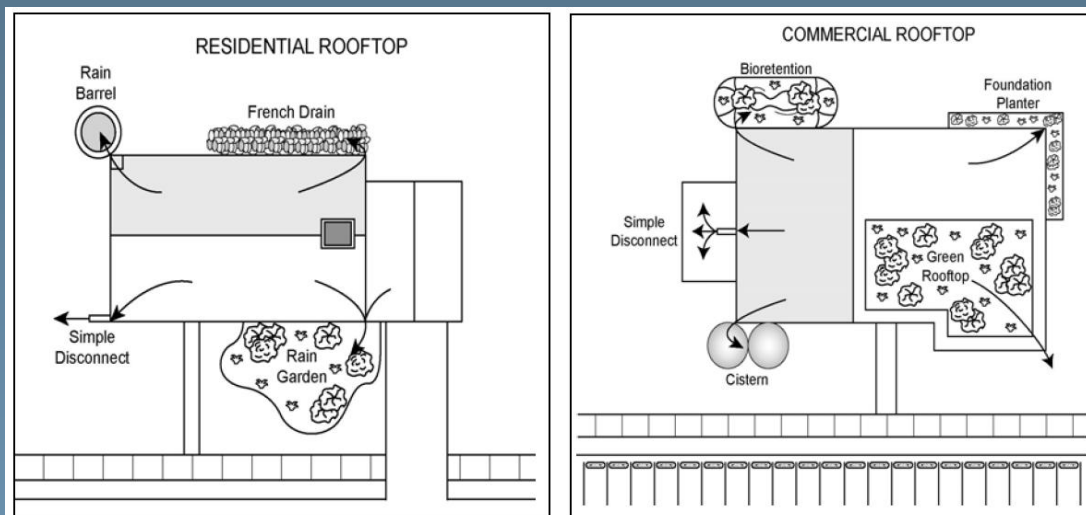
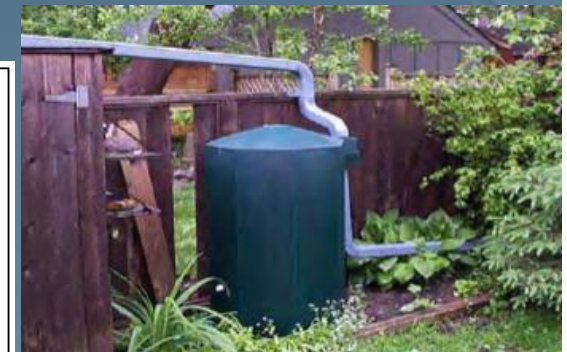
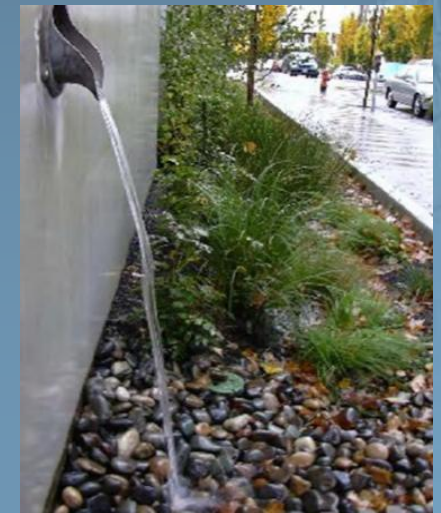
# Residential Rooftop Disconnection

- Residential areas contribute large quantity of runoff to storm drainage system

- Require LID and rooftop disconnection for new projects
- Disconnection retrofit program

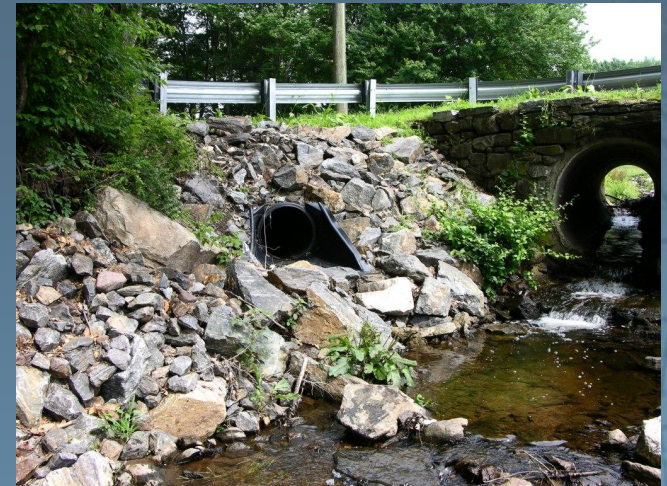
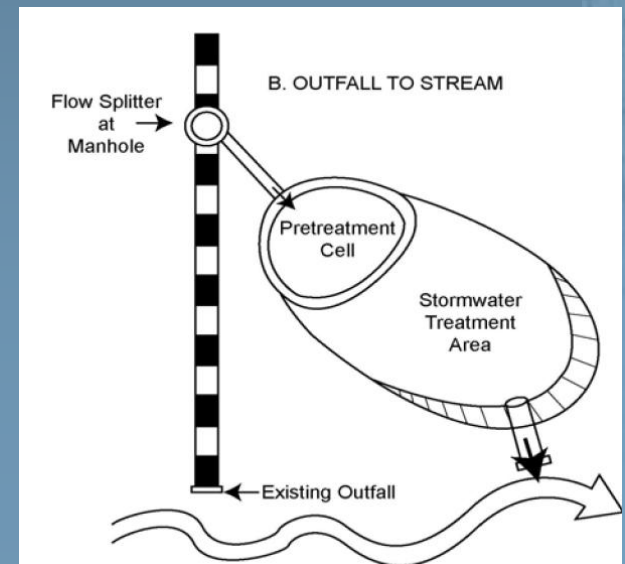
# Stormwater Outfall Retrofits

- Untreated road runoff
- Source of sediment and pollutants
- Opportunity to retrofit existing outfalls
- Plan identifies potential outfall retrofit candidates
- Need further site-specific evaluation to verify feasibility

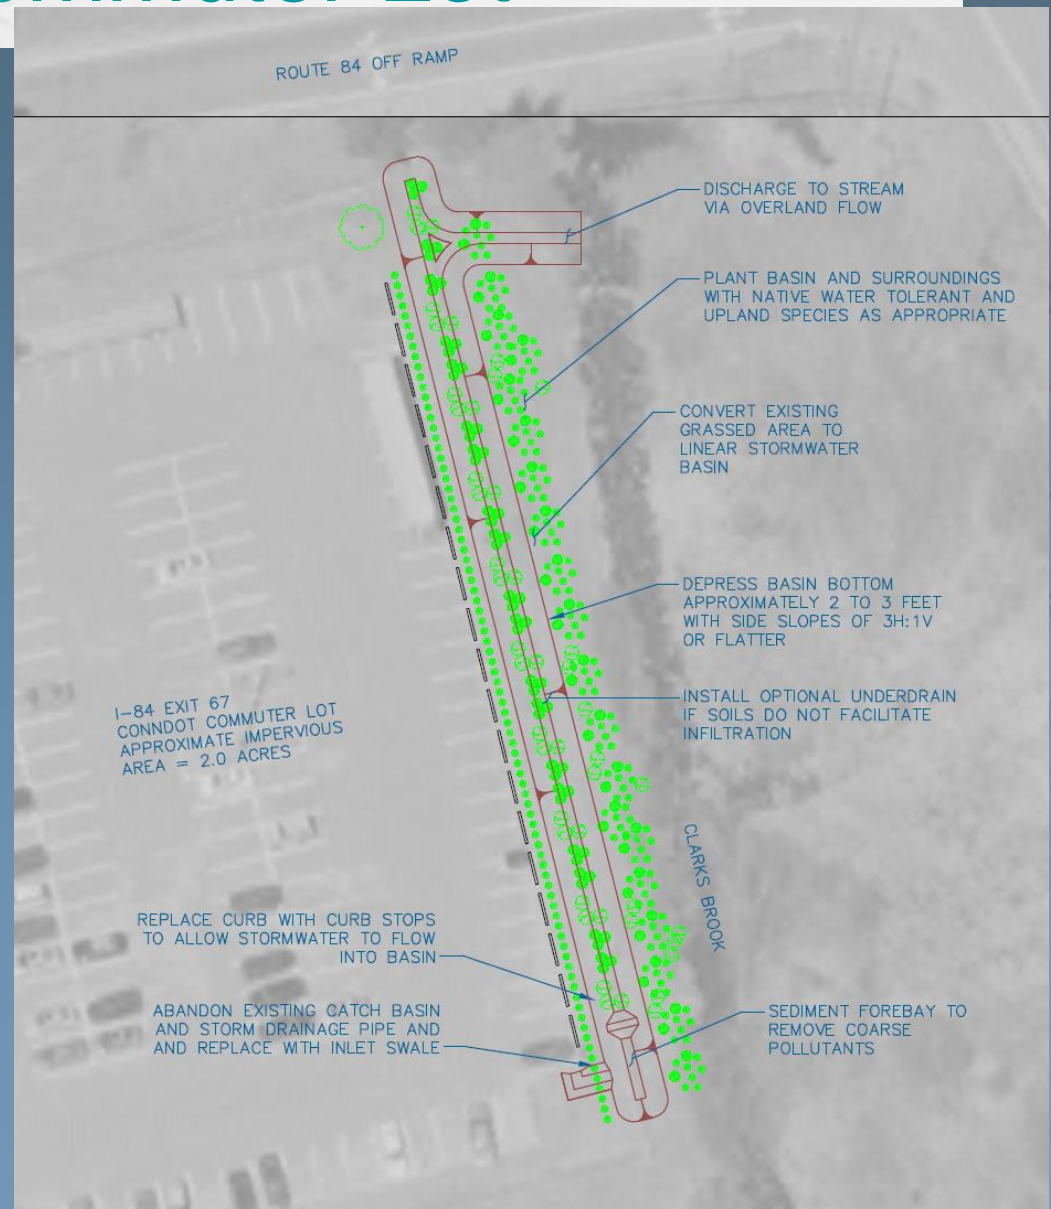
# I-84 Exit 67 Commuter Lot

- Install narrow bioretention basin and sediment forebay
- Cost estimated at \$53,000
